DELAWARE RIVER BASIN  
MANTUA CREEK, GLOUCESTER COUNTY  
NEW JERSEY

# BETHEL LAKE DAM

## NJ00406

PHASE 1 INSPECTION REPORT  
NATIONAL DAM SAFETY PROGRAM.

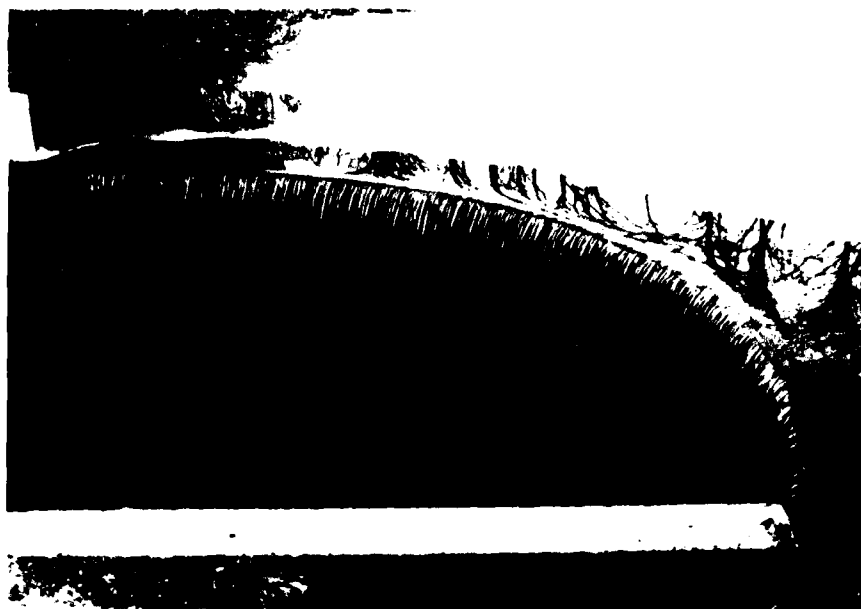
The crest of the horseshoe shaped concrete spillway appeared to be in satisfactory condition. The downstream face of the spillway could not be properly observed because it was obscured by overflow. No outlet works operating mechanism was observed.

PHOTO 1  
SPILLWAY

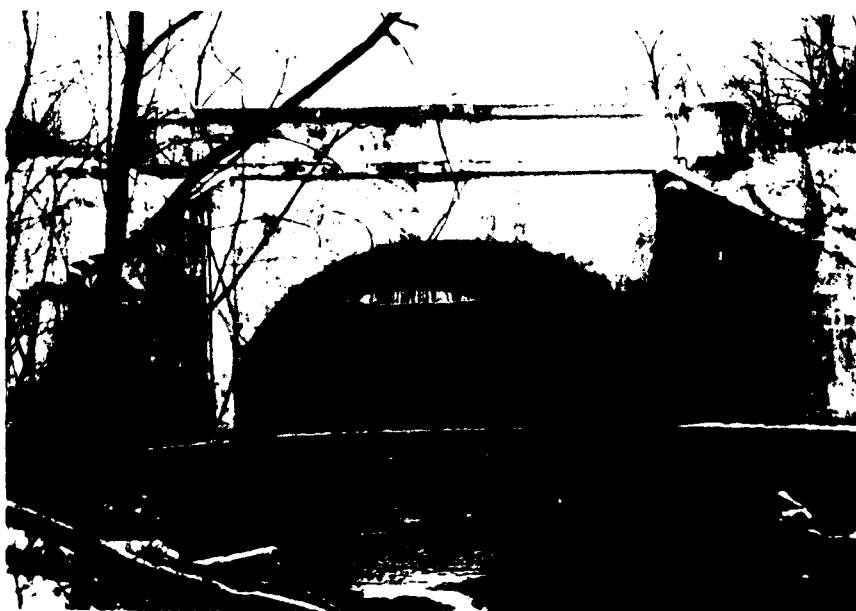
The arch culvert bridge appeared to be structurally sound on the downstream side with no significant cracks observed. The concrete surfaces in general appeared to be in satisfactory condition. Reinforcing steel was observed at the concrete surface within the culvert, apparently resulting from improper placement during construction.

PHOTO 2  
DOWNSTREAM VIEW OF BRIDGE AND SPILLWAY
